01396.01 Feas Study

Figure 4-13
Habitat Restoration Option 3:
Pond Emphasis

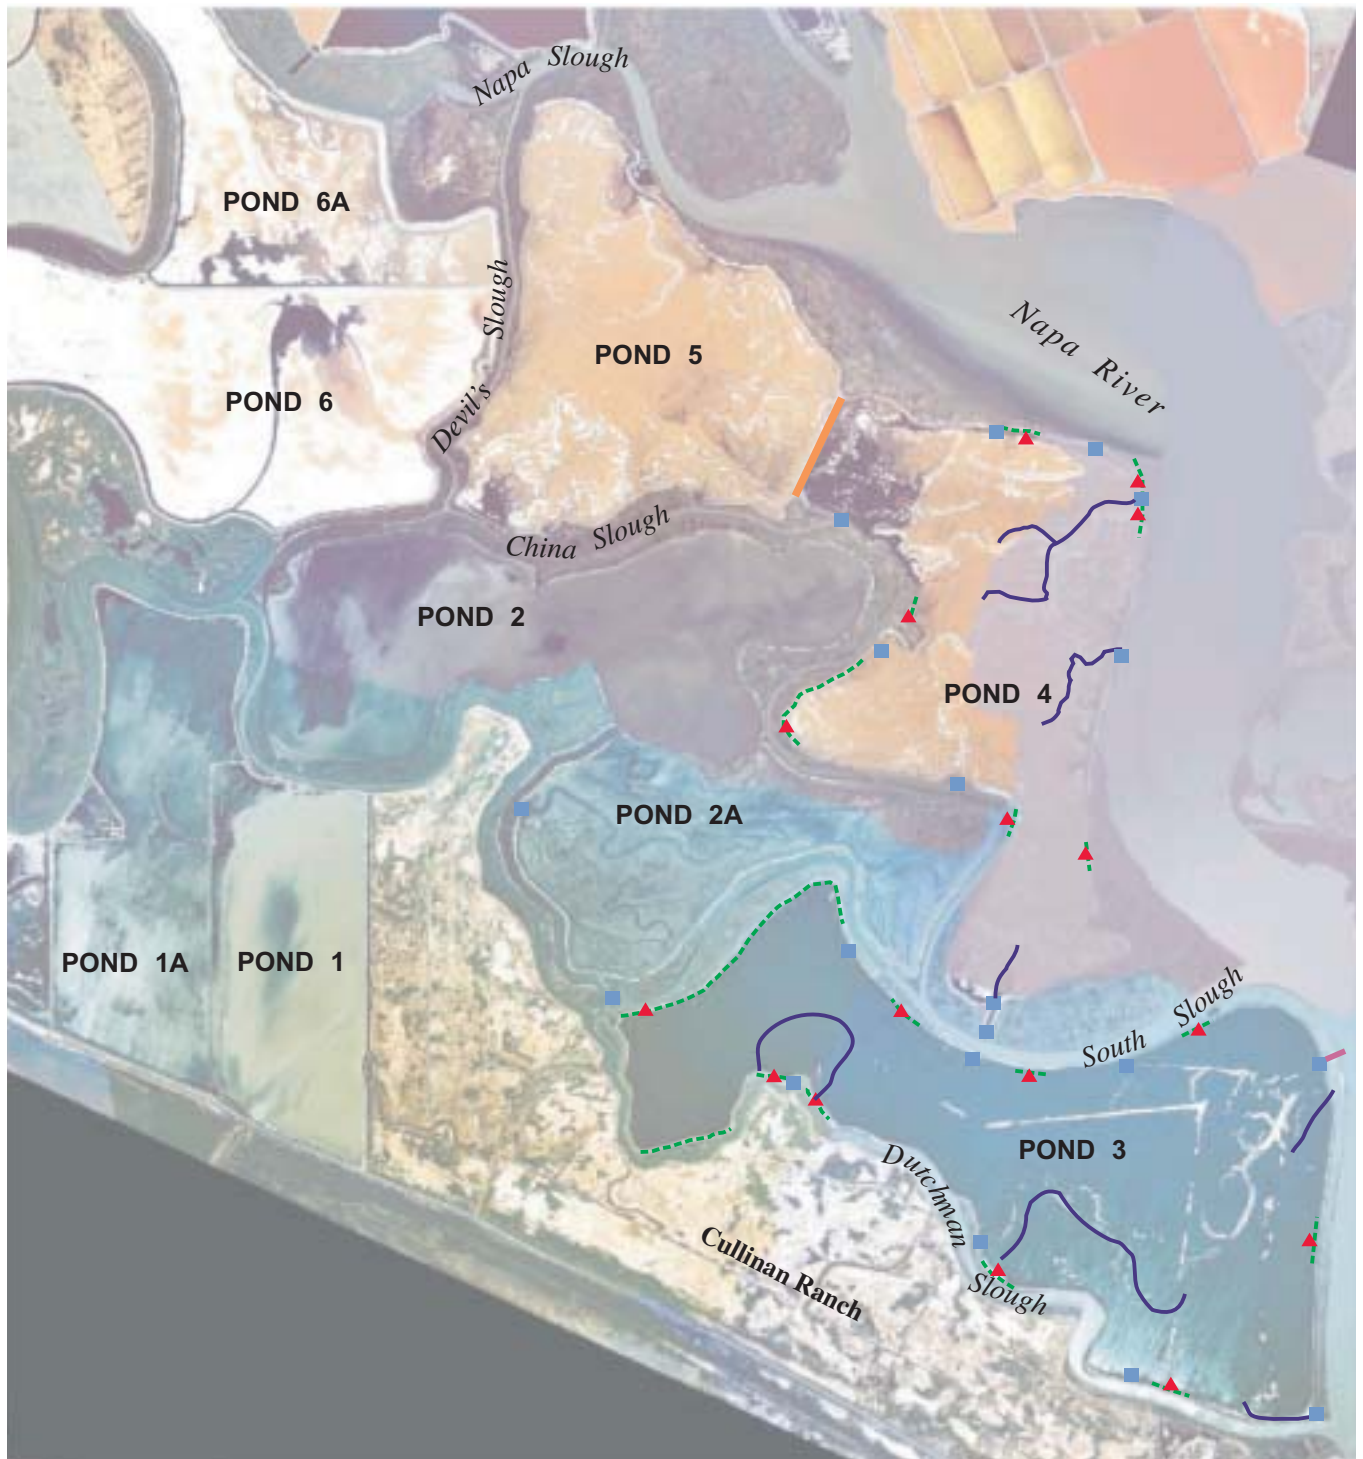
- breach
- ~ starter channel with berms
- ▲ ditch block
- - - lowered levee
- improved levee
